LEA ROAD RAMP

DRONFIELD

HERITAGE IMPACT ASSESSMENT

REPORT ref. no. 37123/3/HIA

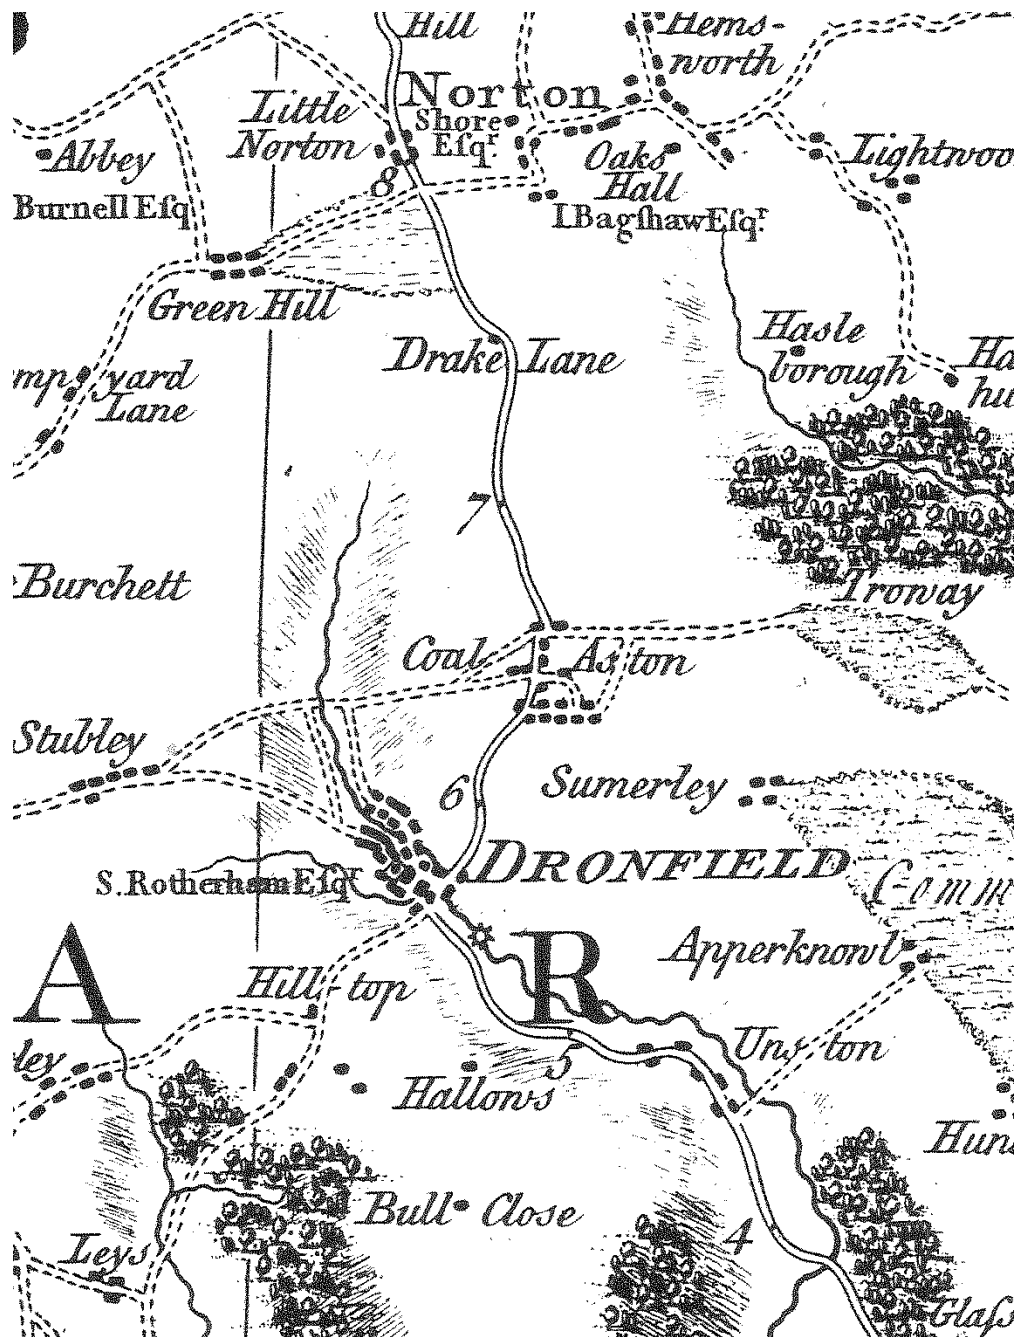
Figure 2 – Extract from Burdett's Map of Derbyshire 1791 – note the Duffield to Sheffield turnpike road passing through Coal Aston

Chesterfield Road appears to have developed from the pre-turnpike Road on the east side of the River Drone in Dronfield (Figure 2).

This road was later incorporated into the Duffield to Sheffield turnpike road circa 1797. Shaw Lane was a continuation of Lea Road and is shown on the Dronfield Enclosure Map of 1846 running from higher ground to the east of Dronfield Church to meet Soaper Lane before crossing the River Drone by Dyer's Bridge which was near the north end of the present Lea Road Bridge.

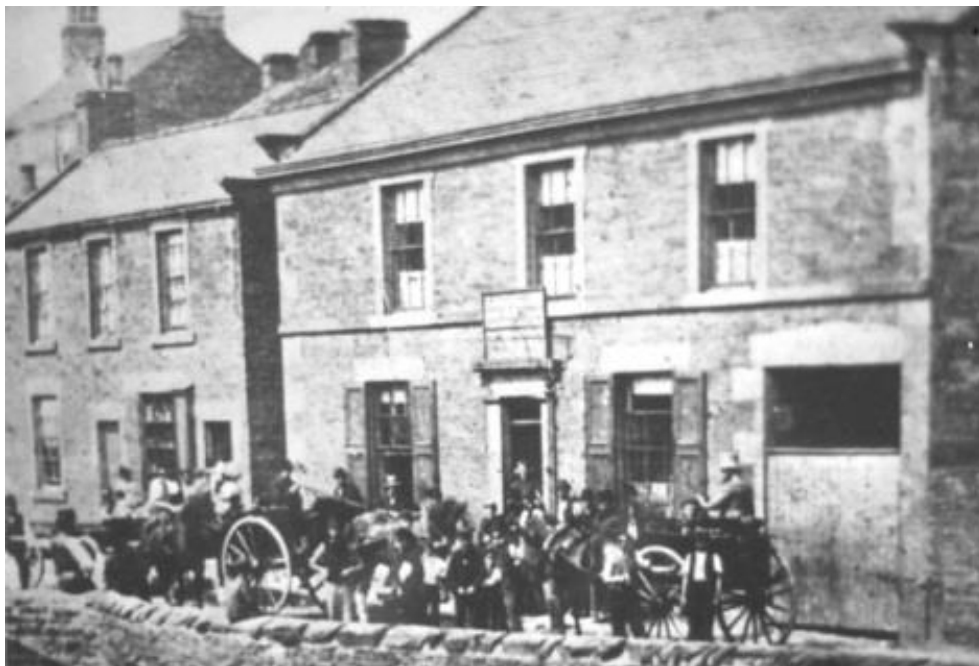
Figure 4 – Bridge Inn showing Dyer's Bridge in the bottom left corner (pre 1870)

The Bridge Inn on Chesterfield Road was built opposite Dyer's Bridge and pre-dates the construction of Lea Road Bridge (Figure 4). South of Dyer's bridge, Chesterfield Road ran alongside the millpond of Upper Mill (Stroud, 2004).

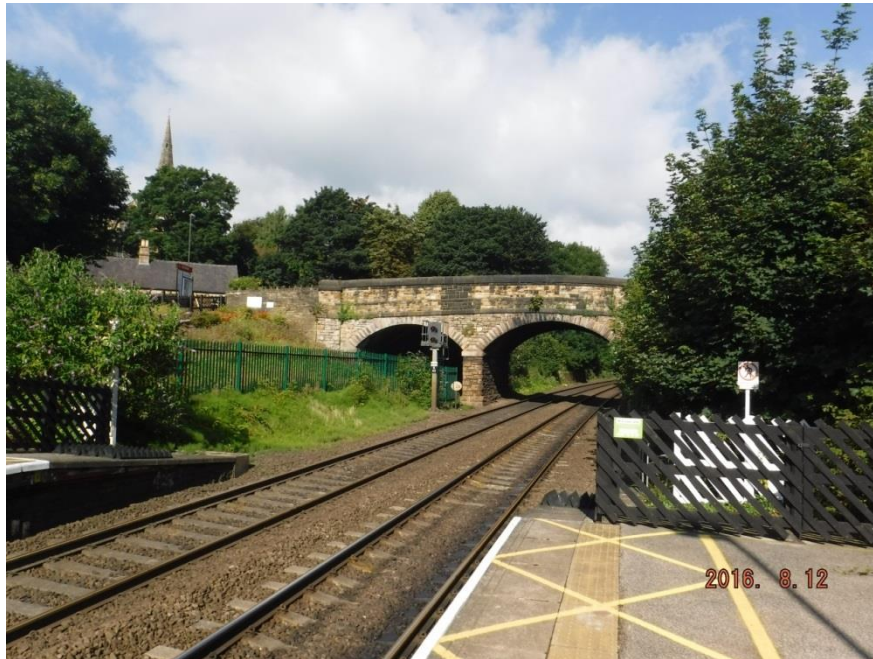
Figure 5 – twin arch spans of Lea Road Bridge over the railway

Shaw Lane was diverted by an continuation of Lea Road which crossed the railway by a twin arch bridge (Figure 5) and then turned through a right angled bend and was carried on a further twin arch structure down towards Chesterfield road (Figure 6).

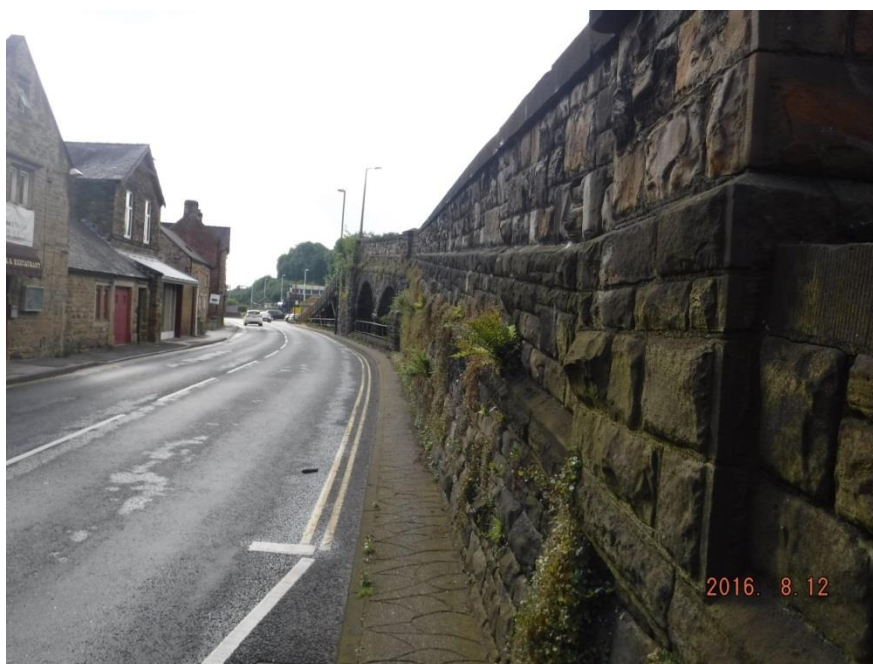
Figure 6 – twin arch spans of Lea Road Bridge and ramp carrying Lea Road along the line of the River Drone

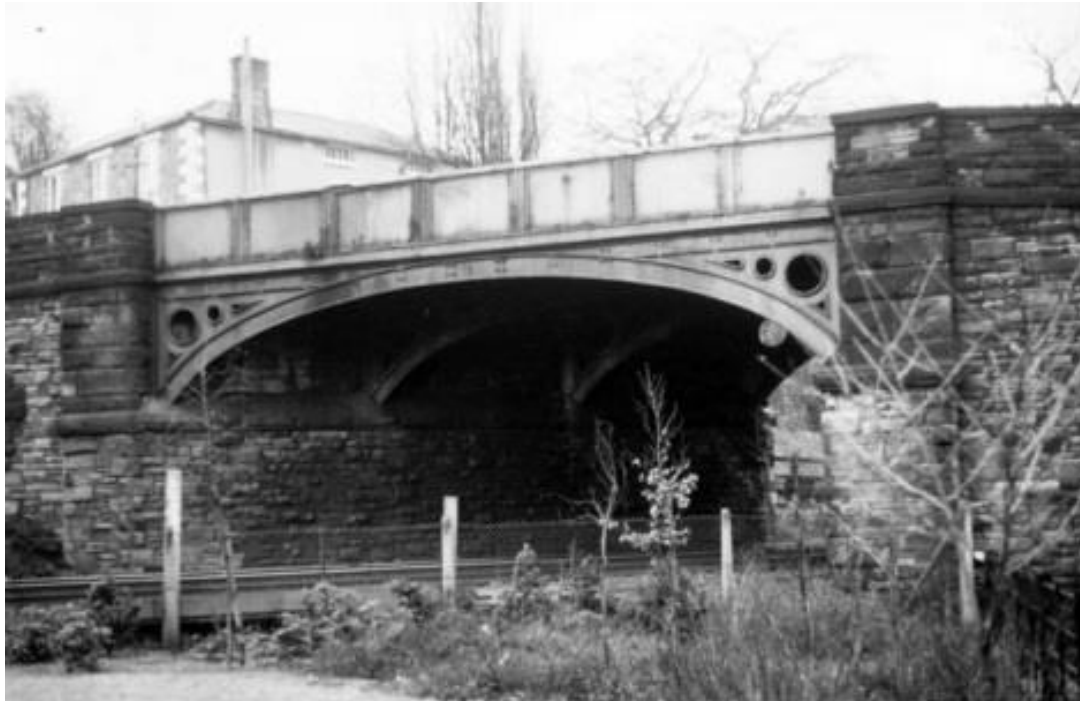
Figure 7 – Soaper Lane Railway Bridge

Soaper Lane was diverted with an acute bend and crossed the railway via a skewed bridge before ramping down to Chesterfield Road near its junction with Snape Hill (Figure 7).

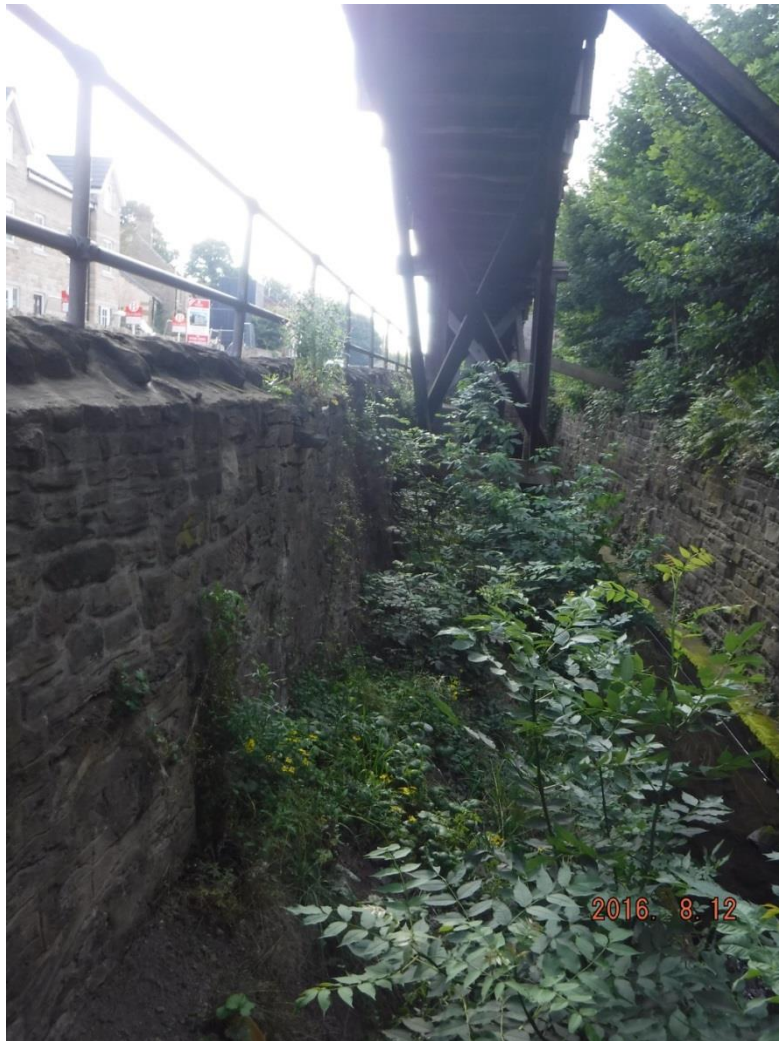
Figure 9 – Training walls to River Drone underneath Lea Road Ramp

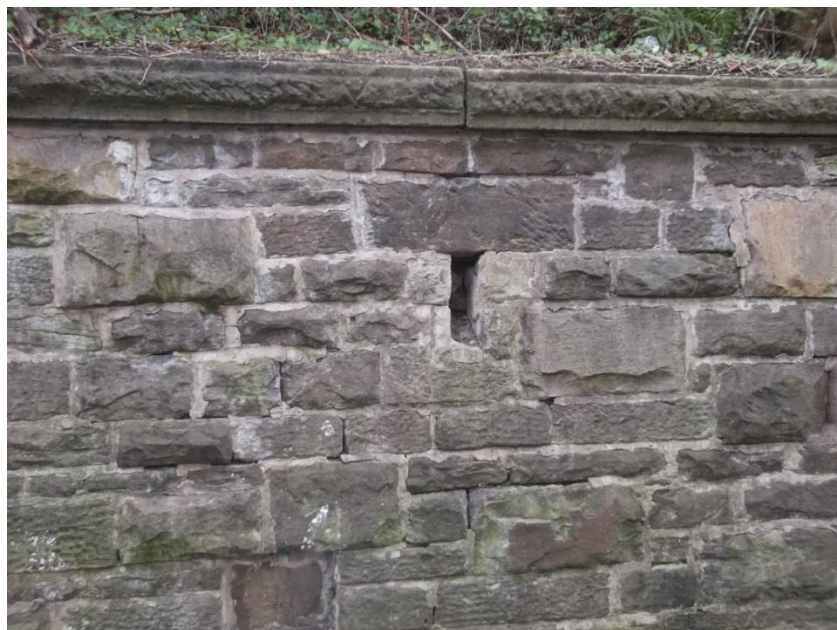
Figure 10 – Socket in railway retaining wall – probably representing a socket for prop opposite Pier C

It is likely that the retaining wall to the west of Lea Road Bridge was constructed at this time to support the railway and act as a training wall for the River Drone. Slots which are still present in the wall are likely to be for props to provide lateral stability to Lea Road Ramp and may be original (Figure 10).

The deck of the ramp has two lateral timber props at approximately third points along its length which are anchored in the bank above a retaining wall on the west bank of the River Drone. Sockets in the railway retaining wall and drawing evidence from the 1922 strengthening scheme indicate that the ramp was originally propped at 5 locations and that the railway retaining wall and the ramp are contemporaneous. The likely date of construction is 1870.

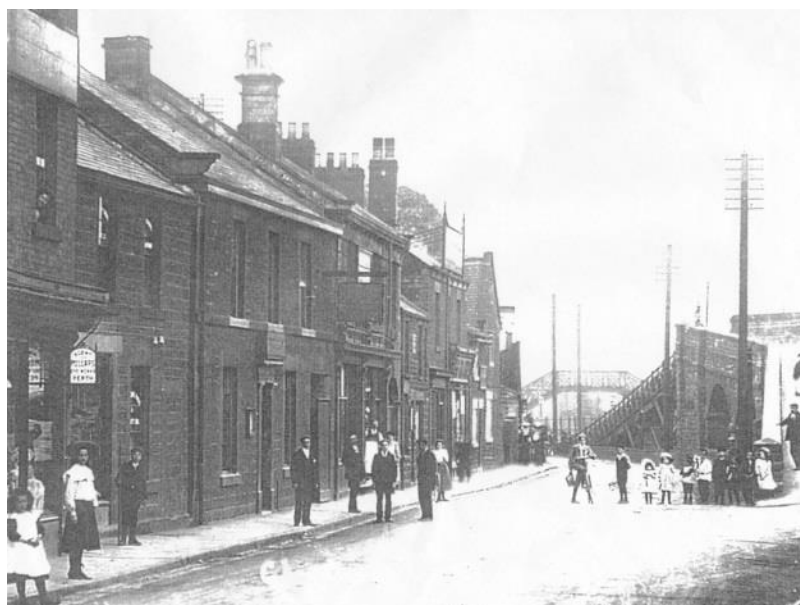
Figure 15 – view looking south down Chesterfield Road with Lea Road Ramp in its present polygonal arch form circa 1910

Photographic evidence from circa 1910 shows that Lea Road Ramp was in its current form and also that the station footbridge was of a timber truss form with in span steps (Figure 15).

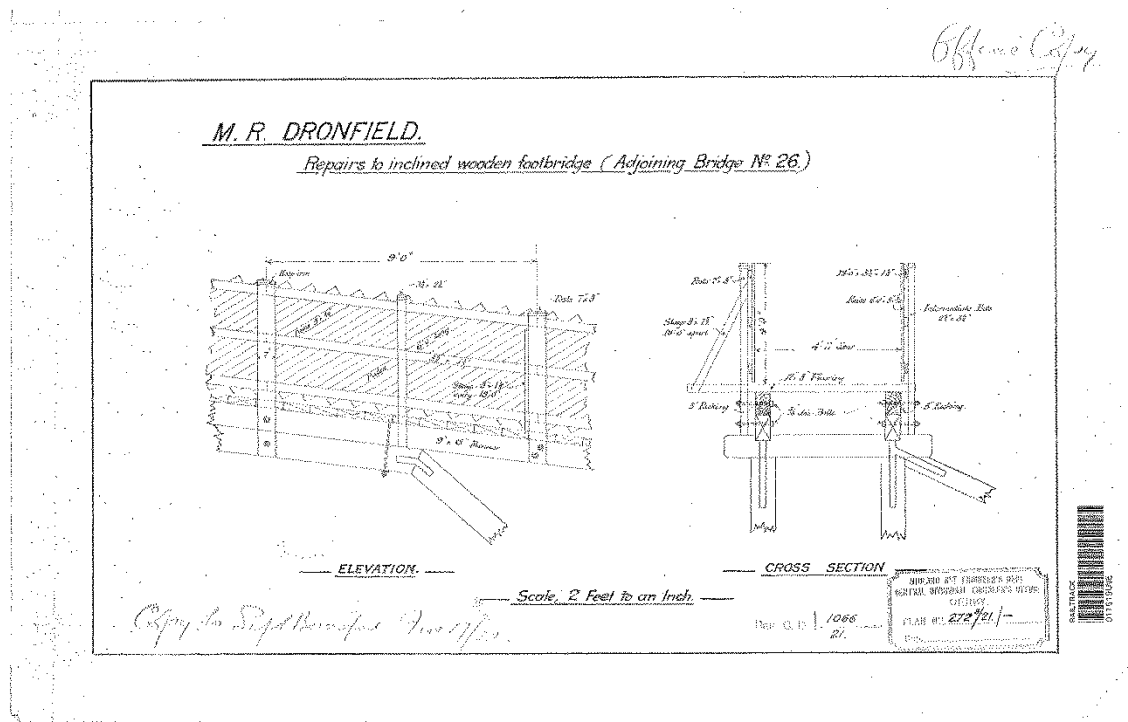
Figure 18 – 1921 scheme for replacement parapet and decking

The parapet was totally replaced with a new system with a 9'0" module which included diagonal creosoted pales (Figure 18). This meant that the parapet post modules did not fit the span modules as had previously been the case when there were three parapet modules per span. This drawing may represent part of the scheme carried out in 1922.

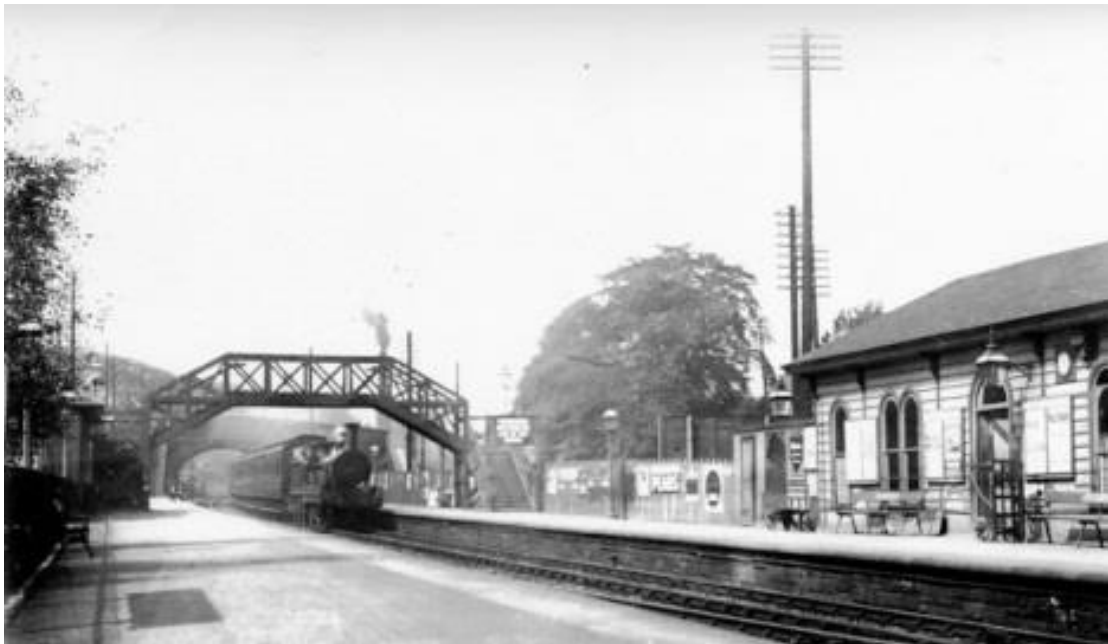
Figure 19 – Dronfield Station and timber footbridge circa 1900 – note Lea Road Ramp in background

Also carried out in 1922 was a scheme to replace the timber footbridge (Figure 19) connecting the platforms with the present structure (Salt, 2001).

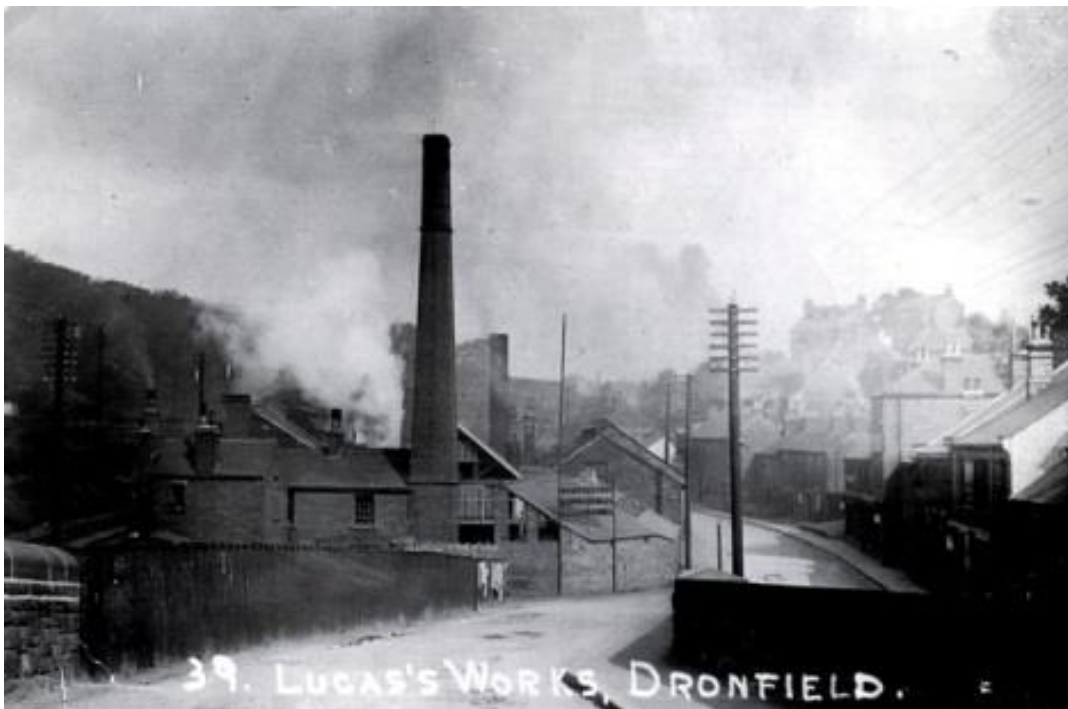
Figure 20 – Lucas's Works from Lea Road Bridge

The setting has become less industrialised recently. Notably there has been closure in 1971 and demolition in 1972-3 of Lucas's Works to the northeast of Lea Road Bridge (Figure 20). This area was converted into a community centre.

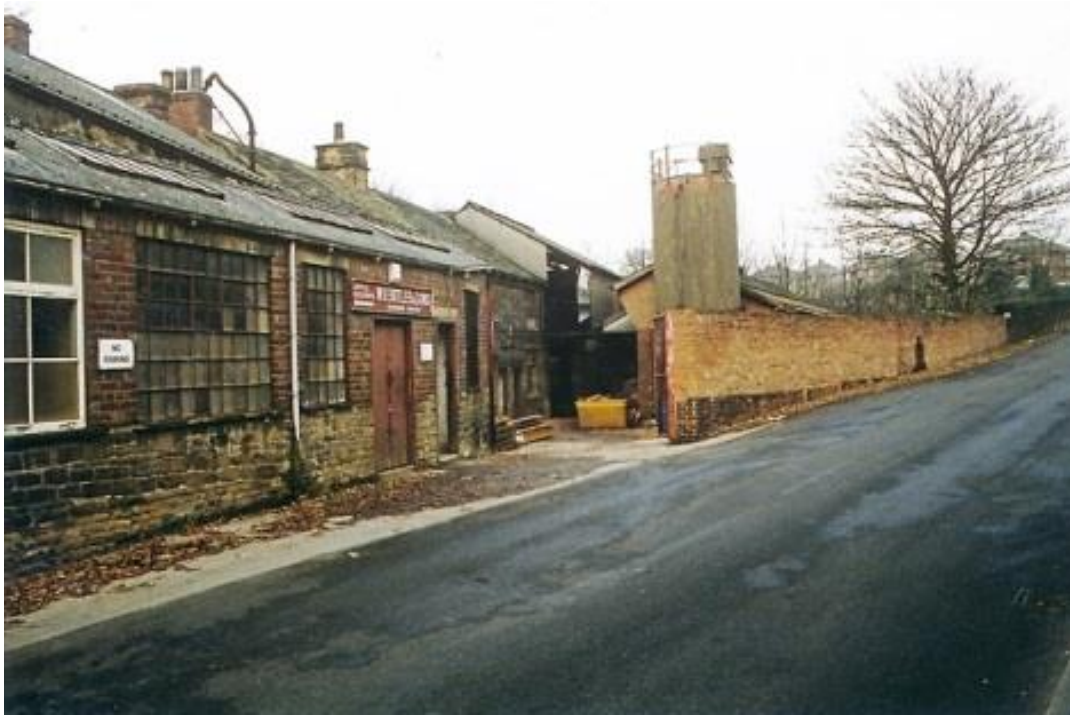
Figure 21 – Butler's Foundry at western end of Lea Road Bridge

Butler's Foundry to the northwest of Lea Road Bridge closed in 1990 and was later converted into The Forge shopping centre in 2004 (Figure 21).

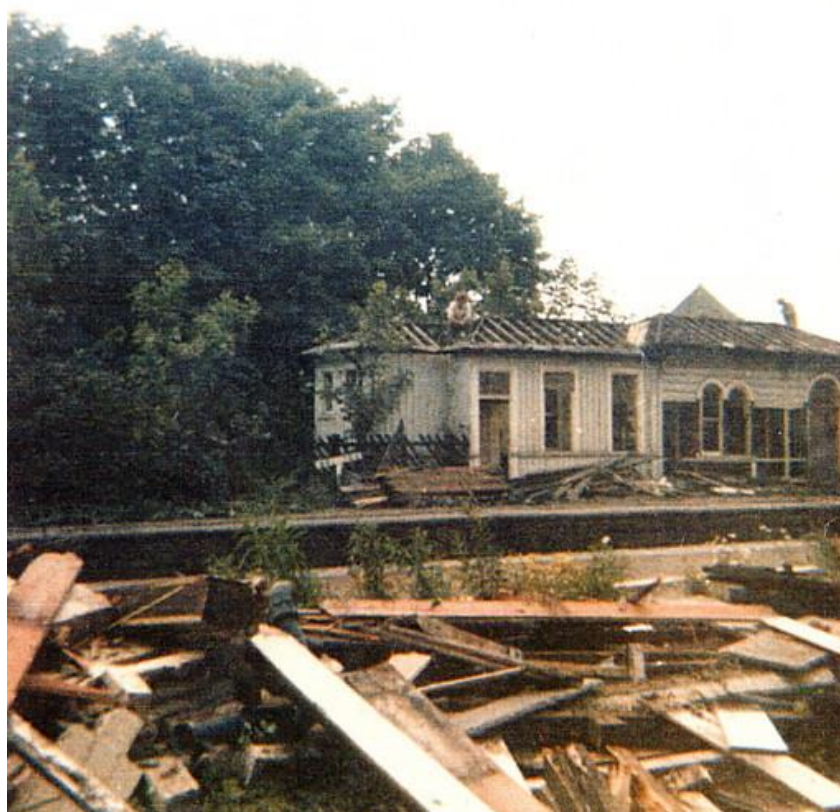
Figure 22 – Demolition of timber station buildings in 1973

Dronfield Station was closed in 1966. The ramp was the subject of a licence agreement between The British Railways Board and The Dronfield Urban District Council dated 24th October 1968. The description of the licence is "To retain a timber ramp footway on the Board's land between Lea Road Bridge and Chesterfield Road". The station buildings were demolished in 1973 (Figure 22).

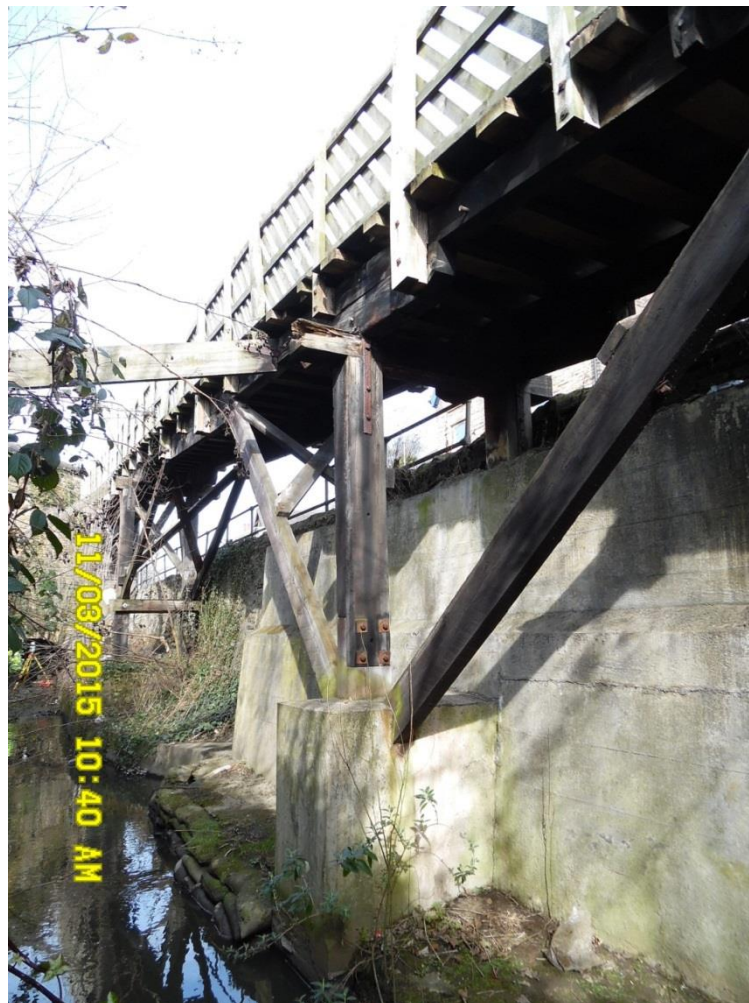
Figure 23 – View looking north towards Pier B

The structure has four main spans of a polygonal arch form and a small cantilever span at the south end. The polygonal arch comprises a pair of raking members from the supports which butt against a straining piece. Supporting the deck is a pair of longitudinal beams, which span between supports and gain support over their central third from the polygonal arch members (Figure 26).

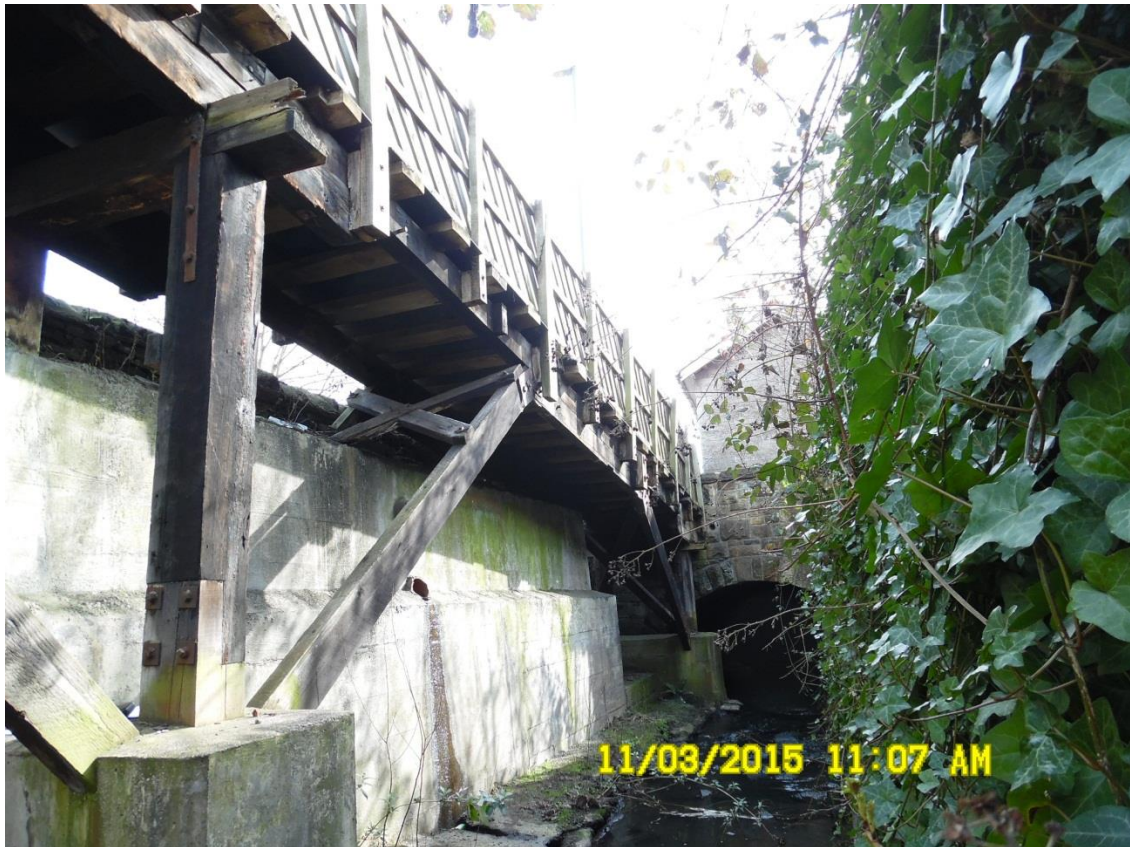
Figure 24 – view looking south towards Span AB

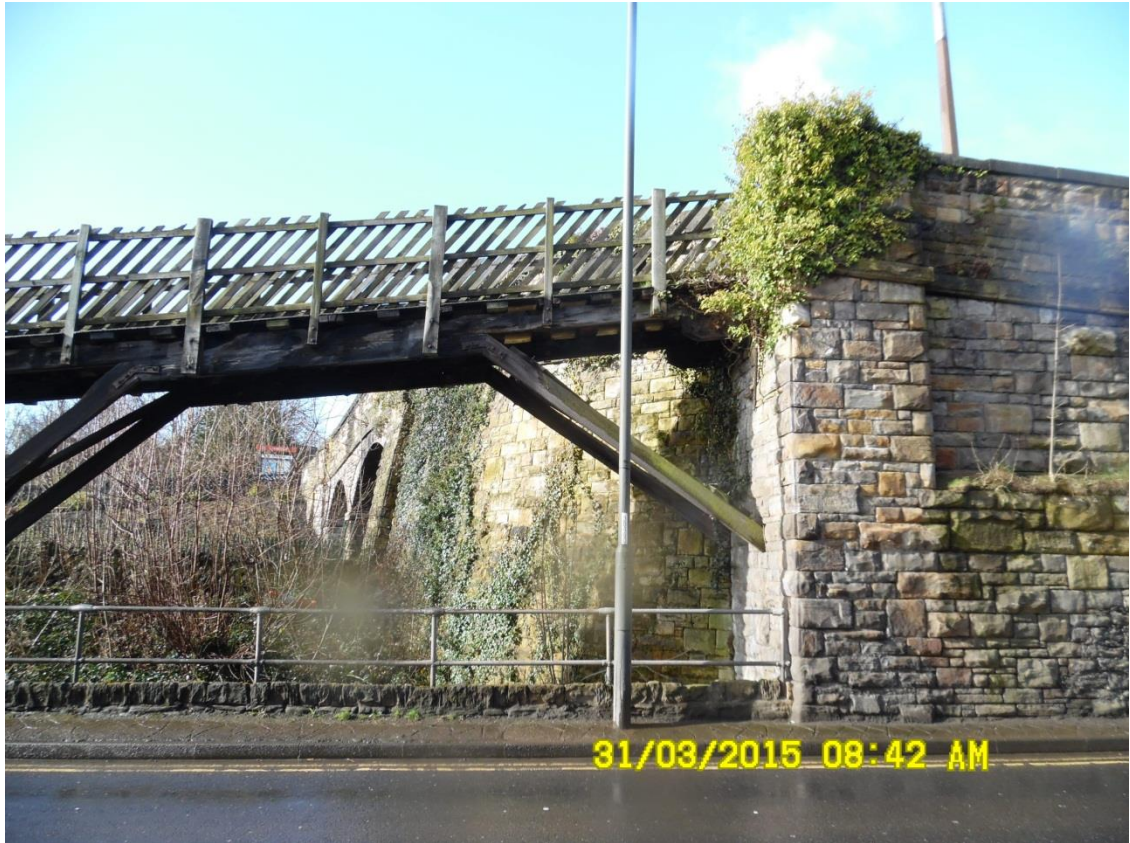
Figure 25 – View looking west of Span DE and Lea Road Bridge abutment

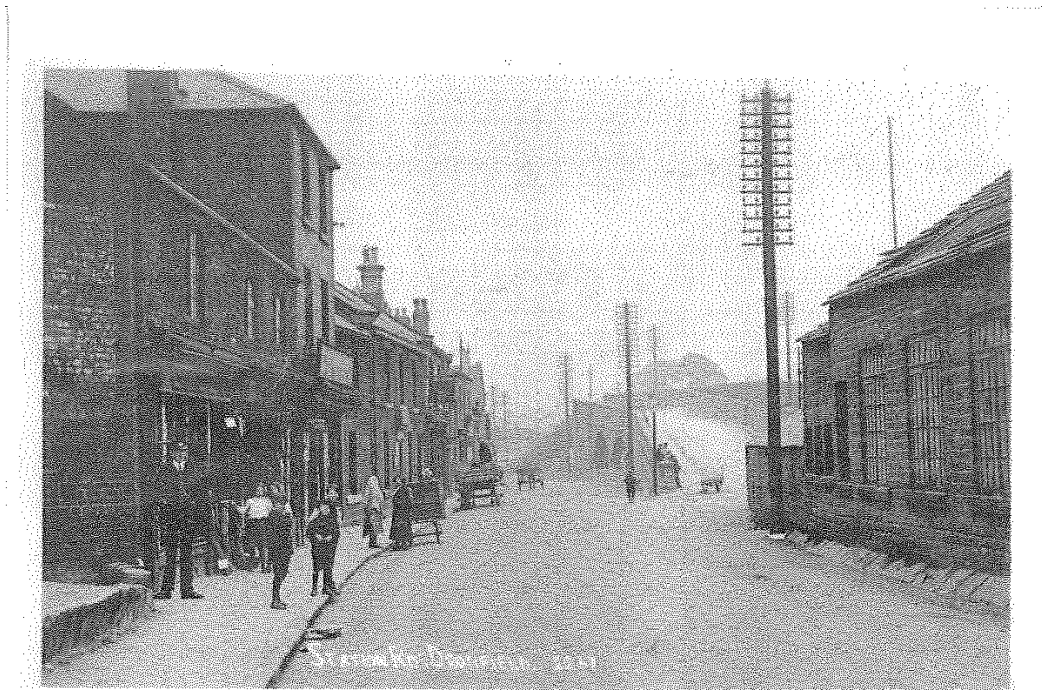
Figure 27 - View from Chesterfield Road looking back towards the ramp circa 1910

The overall appearance of the ramp and Lea Road Bridge has changed little since their construction (compare with Figure 27 with Figure 28). The deteriorating condition of the ramp meant that props were added at the ends and centre of the ramp in February 2017.

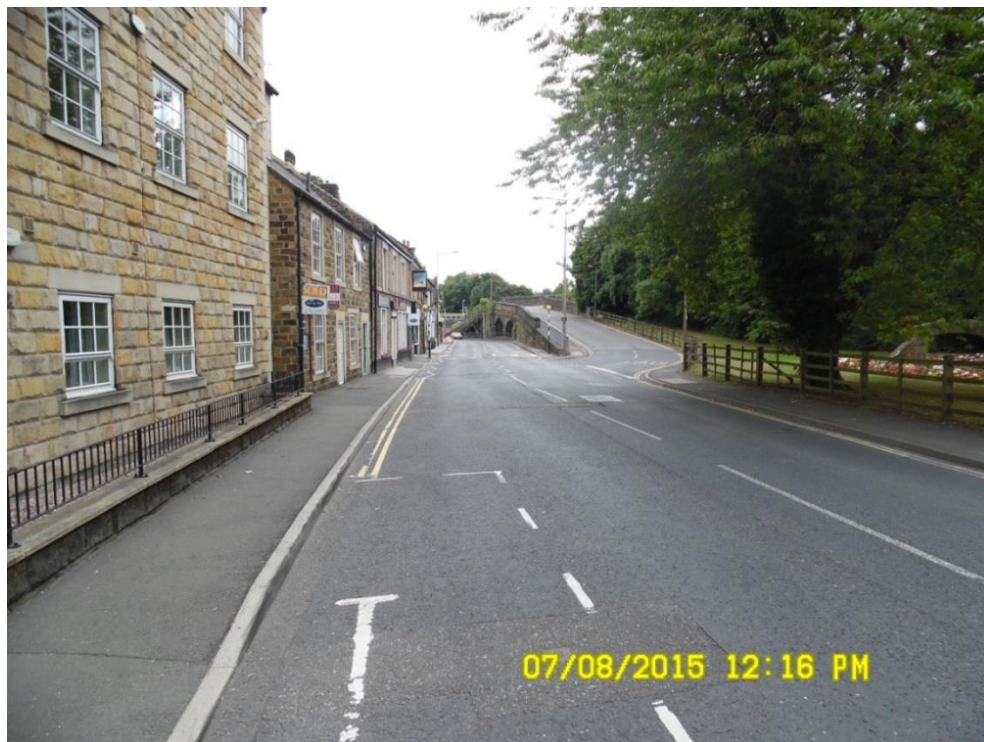
Figure 28 – View from Chesterfield Road looking back towards the ramp 2015

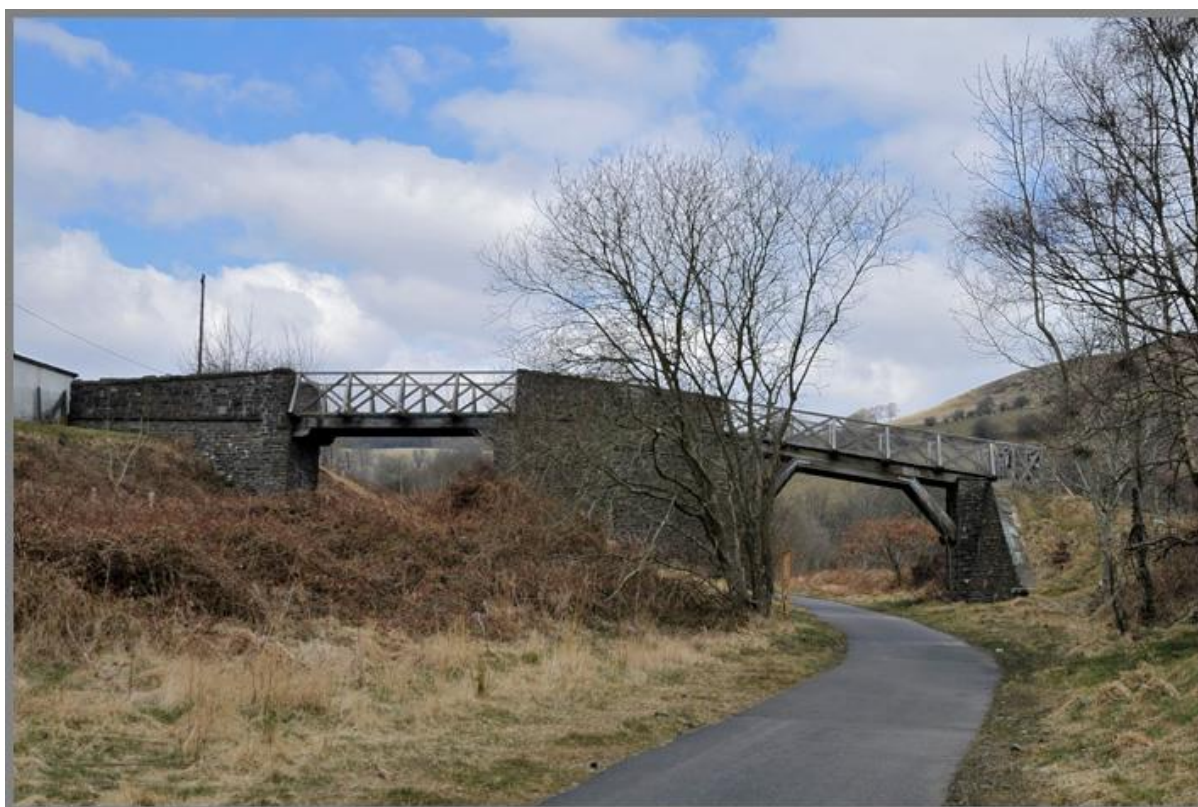
Figure 29 - Ogilvie Halt Footbridges (West left, East right)

The nearest parallel to Lea Road Ramp is the Eastern timber footbridge at Ogilvie Halt (Figure 29). The reason for listing is given as “an exceptionally rare example of a formerly common type of bridge”.
